ABSTRACT

This document describes the known exceptions to the functional specifications (advisories).

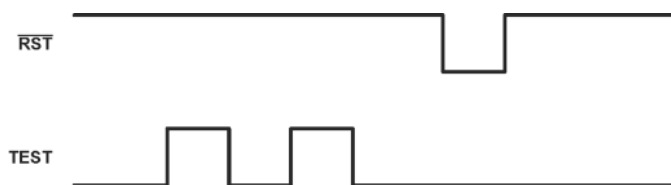
Note: This toggling of TEST pins is not subject to timing constraints. The appropriate level transitions on TEST pin, followed by a RST pulse after 50us, are sufficient to trigger an exit from BSL mode.

- Toggle the TEST pin twice when nRST is high and after 50us pull nRST low.
